Laboratory Reference: CAN14W2481/2

## ADHESION AGENT TEST REPORT

CLIENT REFERENCE: Heat-stability of Otech AGGBIND-75® at 160°C – 24 hours

ADHESION AGENT: Otech AGGBIND-75® liquid adhesion agent

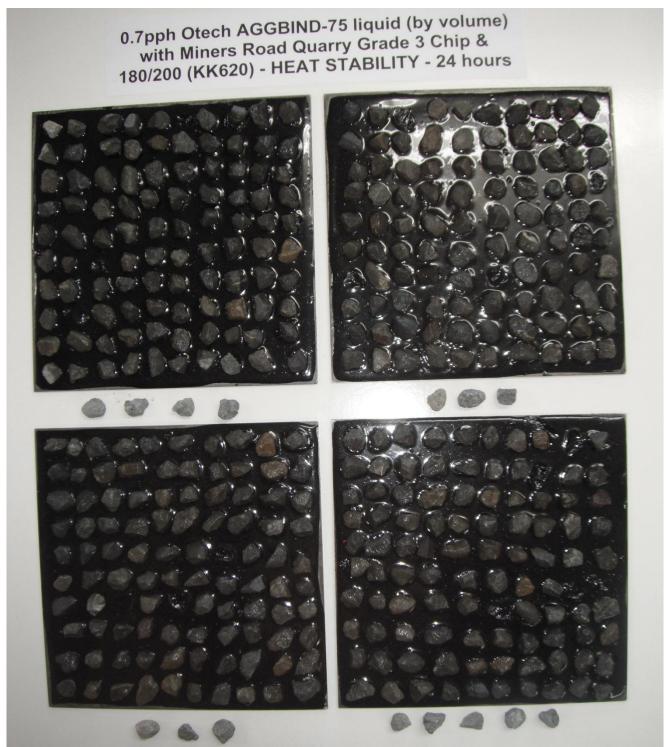
**Figure 1.** Photograph showing test plates with 180/200 bitumen and 0.7pph Otech AGGBIND-75<sup>®</sup> (by volume) after test was performed. Fulton Hogan - Miners Road Grade 3 chip dislodged is arranged below the plates.

AGGREGATE SOURCE	AGENT QUANTITY (PPH BY VOLUME)	TEST CONDITIONS	TEST RESULT	TEST CRITERION
Fulton Hogan Canterbury Miners Road Quarry	0.7	24 hours at 160°C	96	0.50
			Spec: 80 min	Spec : 2 max

**NOTE:** WCS, CLBAA Test Method B301-89T was modified for heat-stability tests. Oven temperature was  $160 \pm 2^{\circ}$ C, mass of bitumen to be doped was increased to 900g, and doped bitumen was held at the stated temperature for the period shown in the results table above.
