**Report No: MAT:AUK13S-02367**  
**Issue No: 1**

## Material Test Report

**Sample ID:** AUK13S-02367  
**Client Sample ID:** FH1  
**Material:** NZTA M/6:2011 Grade 3 Chip  
**Sample Source:** Maramarua - Smythes Quarries  
**Site/Sampled From:** Smythes Quarry Bin  
**Date Sampled:** 29/04/2013  
**Specification:** NZTA M6: 2011 Grade 3 Chip  
**Sampled By:** Client  
**Sampling Method:** Stated to be NZS 4407:1991 2.4.6.1.2  
**Date Tested:** 07/06/2013  
**Technician:** Kate Worboys  
**Sampling Endorsed:** No

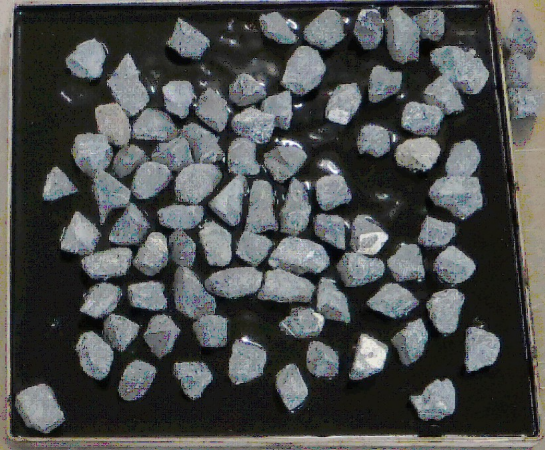
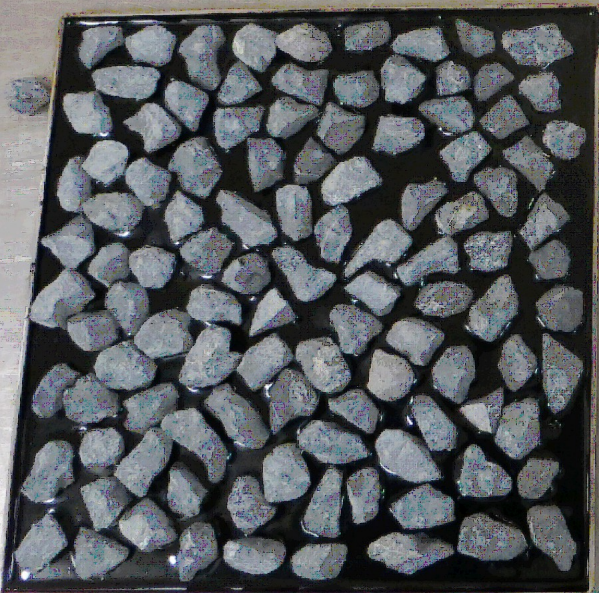
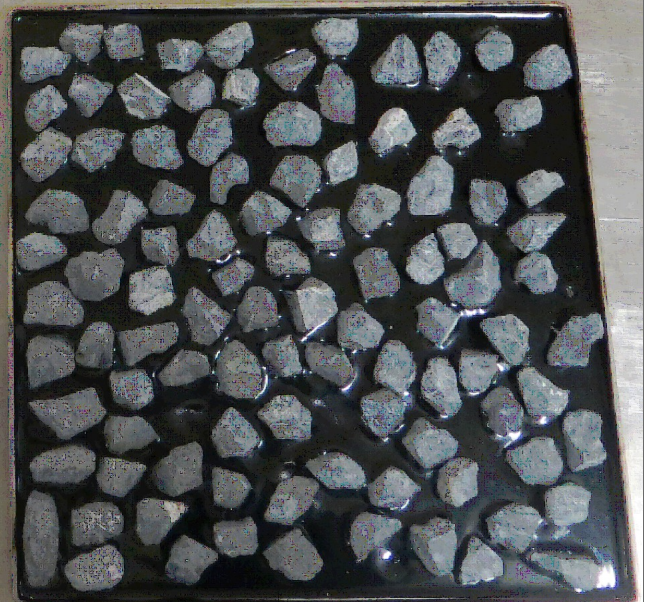
AUK13S-02367  
Smythes Quarry  
0.7ppht

Description	Method	Result	Limits
Adhesion Agent Used	WDSC B301-89T#	Aggbind 75	N/A
Adhesion Agent Dosage [pph]		0.7	N/A
Binder Type		180/200	N/A
Cutter Used			N/A
Cutter Dosage [pph]			N/A
Geological Description of Aggregate		Crushed Aggregate	N/A
Material Sieved Between [mm]		13.2 - 9.5mm	N/A
Sample Washed?		Washed	N/A
Test Temperature [°C]		25.0	N/A
Adhesion Set Up Period [hrs]		2.5	N/A
Adhesion Value		98	≥80
T-Value		1.3	≤2
